GEOTECHNICAL INVESTIGATION REPORT

Proposed Residential Development
63 Redbank Creek Road, Adare

REFERENCE NUMBER
PTP/08869 – 0001 – Rev0

Document Title:	Broadscale Geotechnical Investigation Report – 63 Redbank Creek Road, Adare
Project Number:	PTP/08869
Document ID:	PTP/08869 – 0001 – Rev0
Client:	Parklands at Adare
Client Contact:	Peter Brown

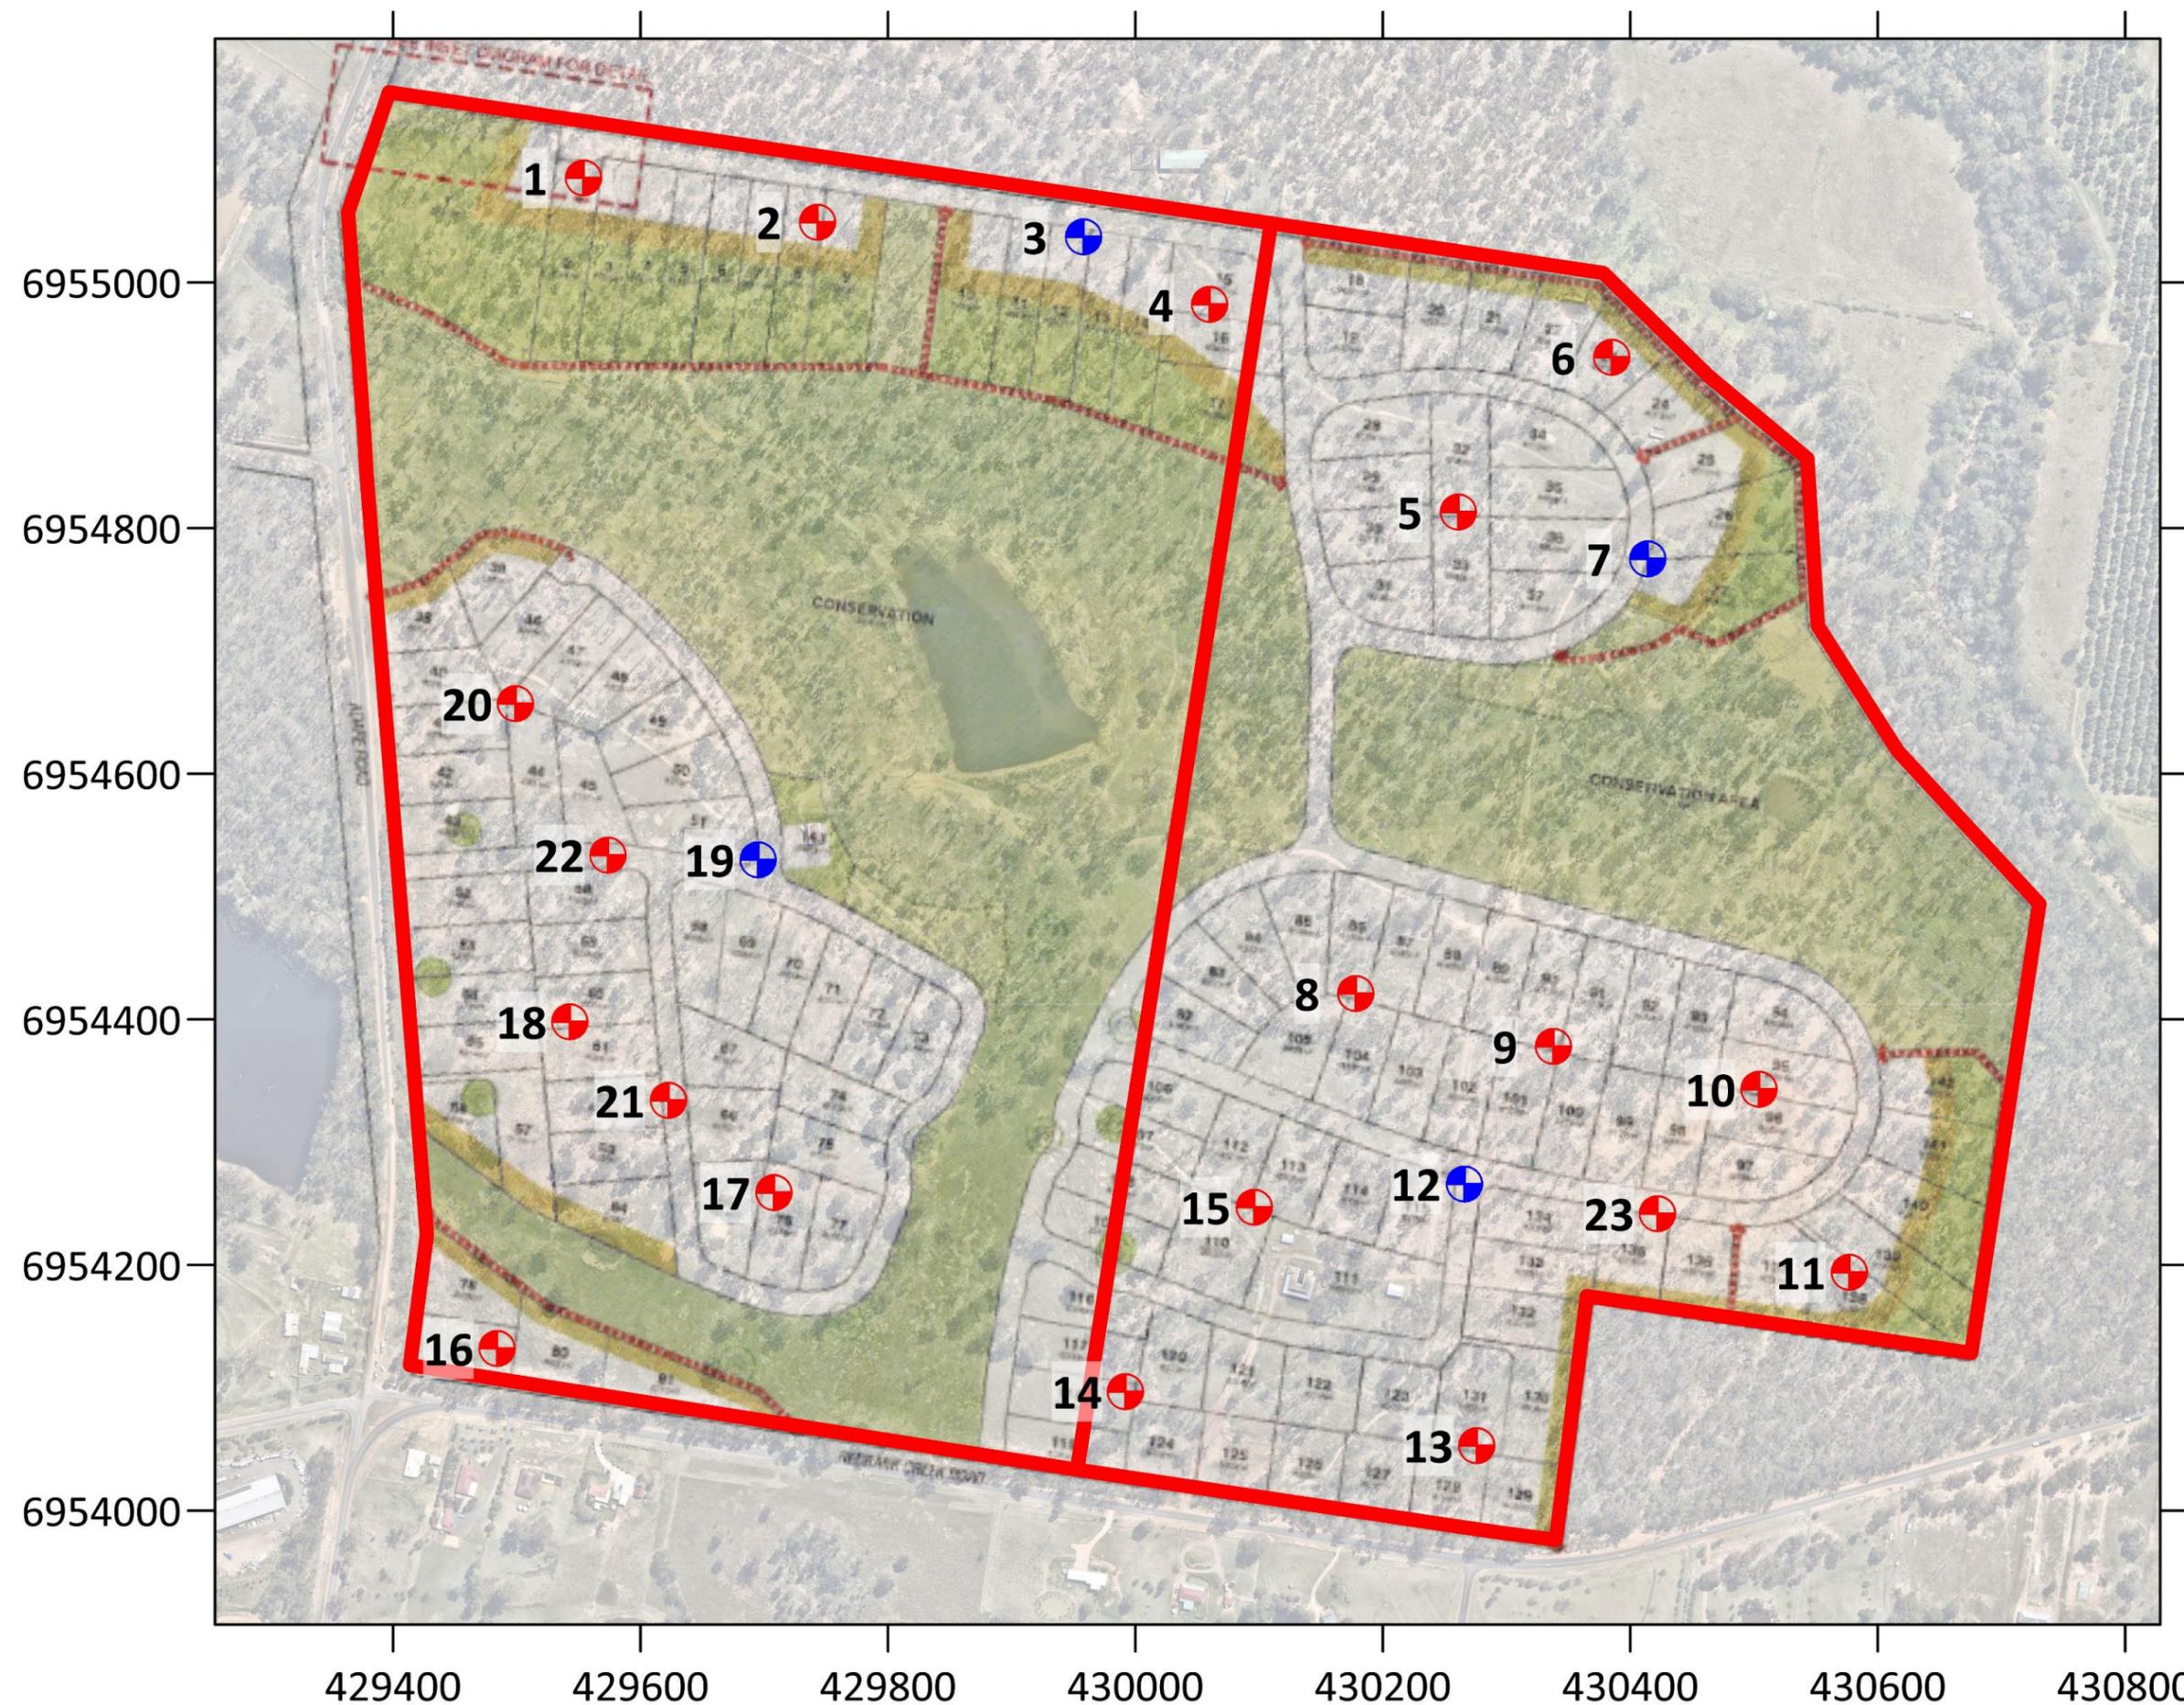
Title: Test Location Plan

Date: 12/04/2022	Drawn: JS	Checked: DV
Project: PTP/08869	Drawing No: 1	Revision 1

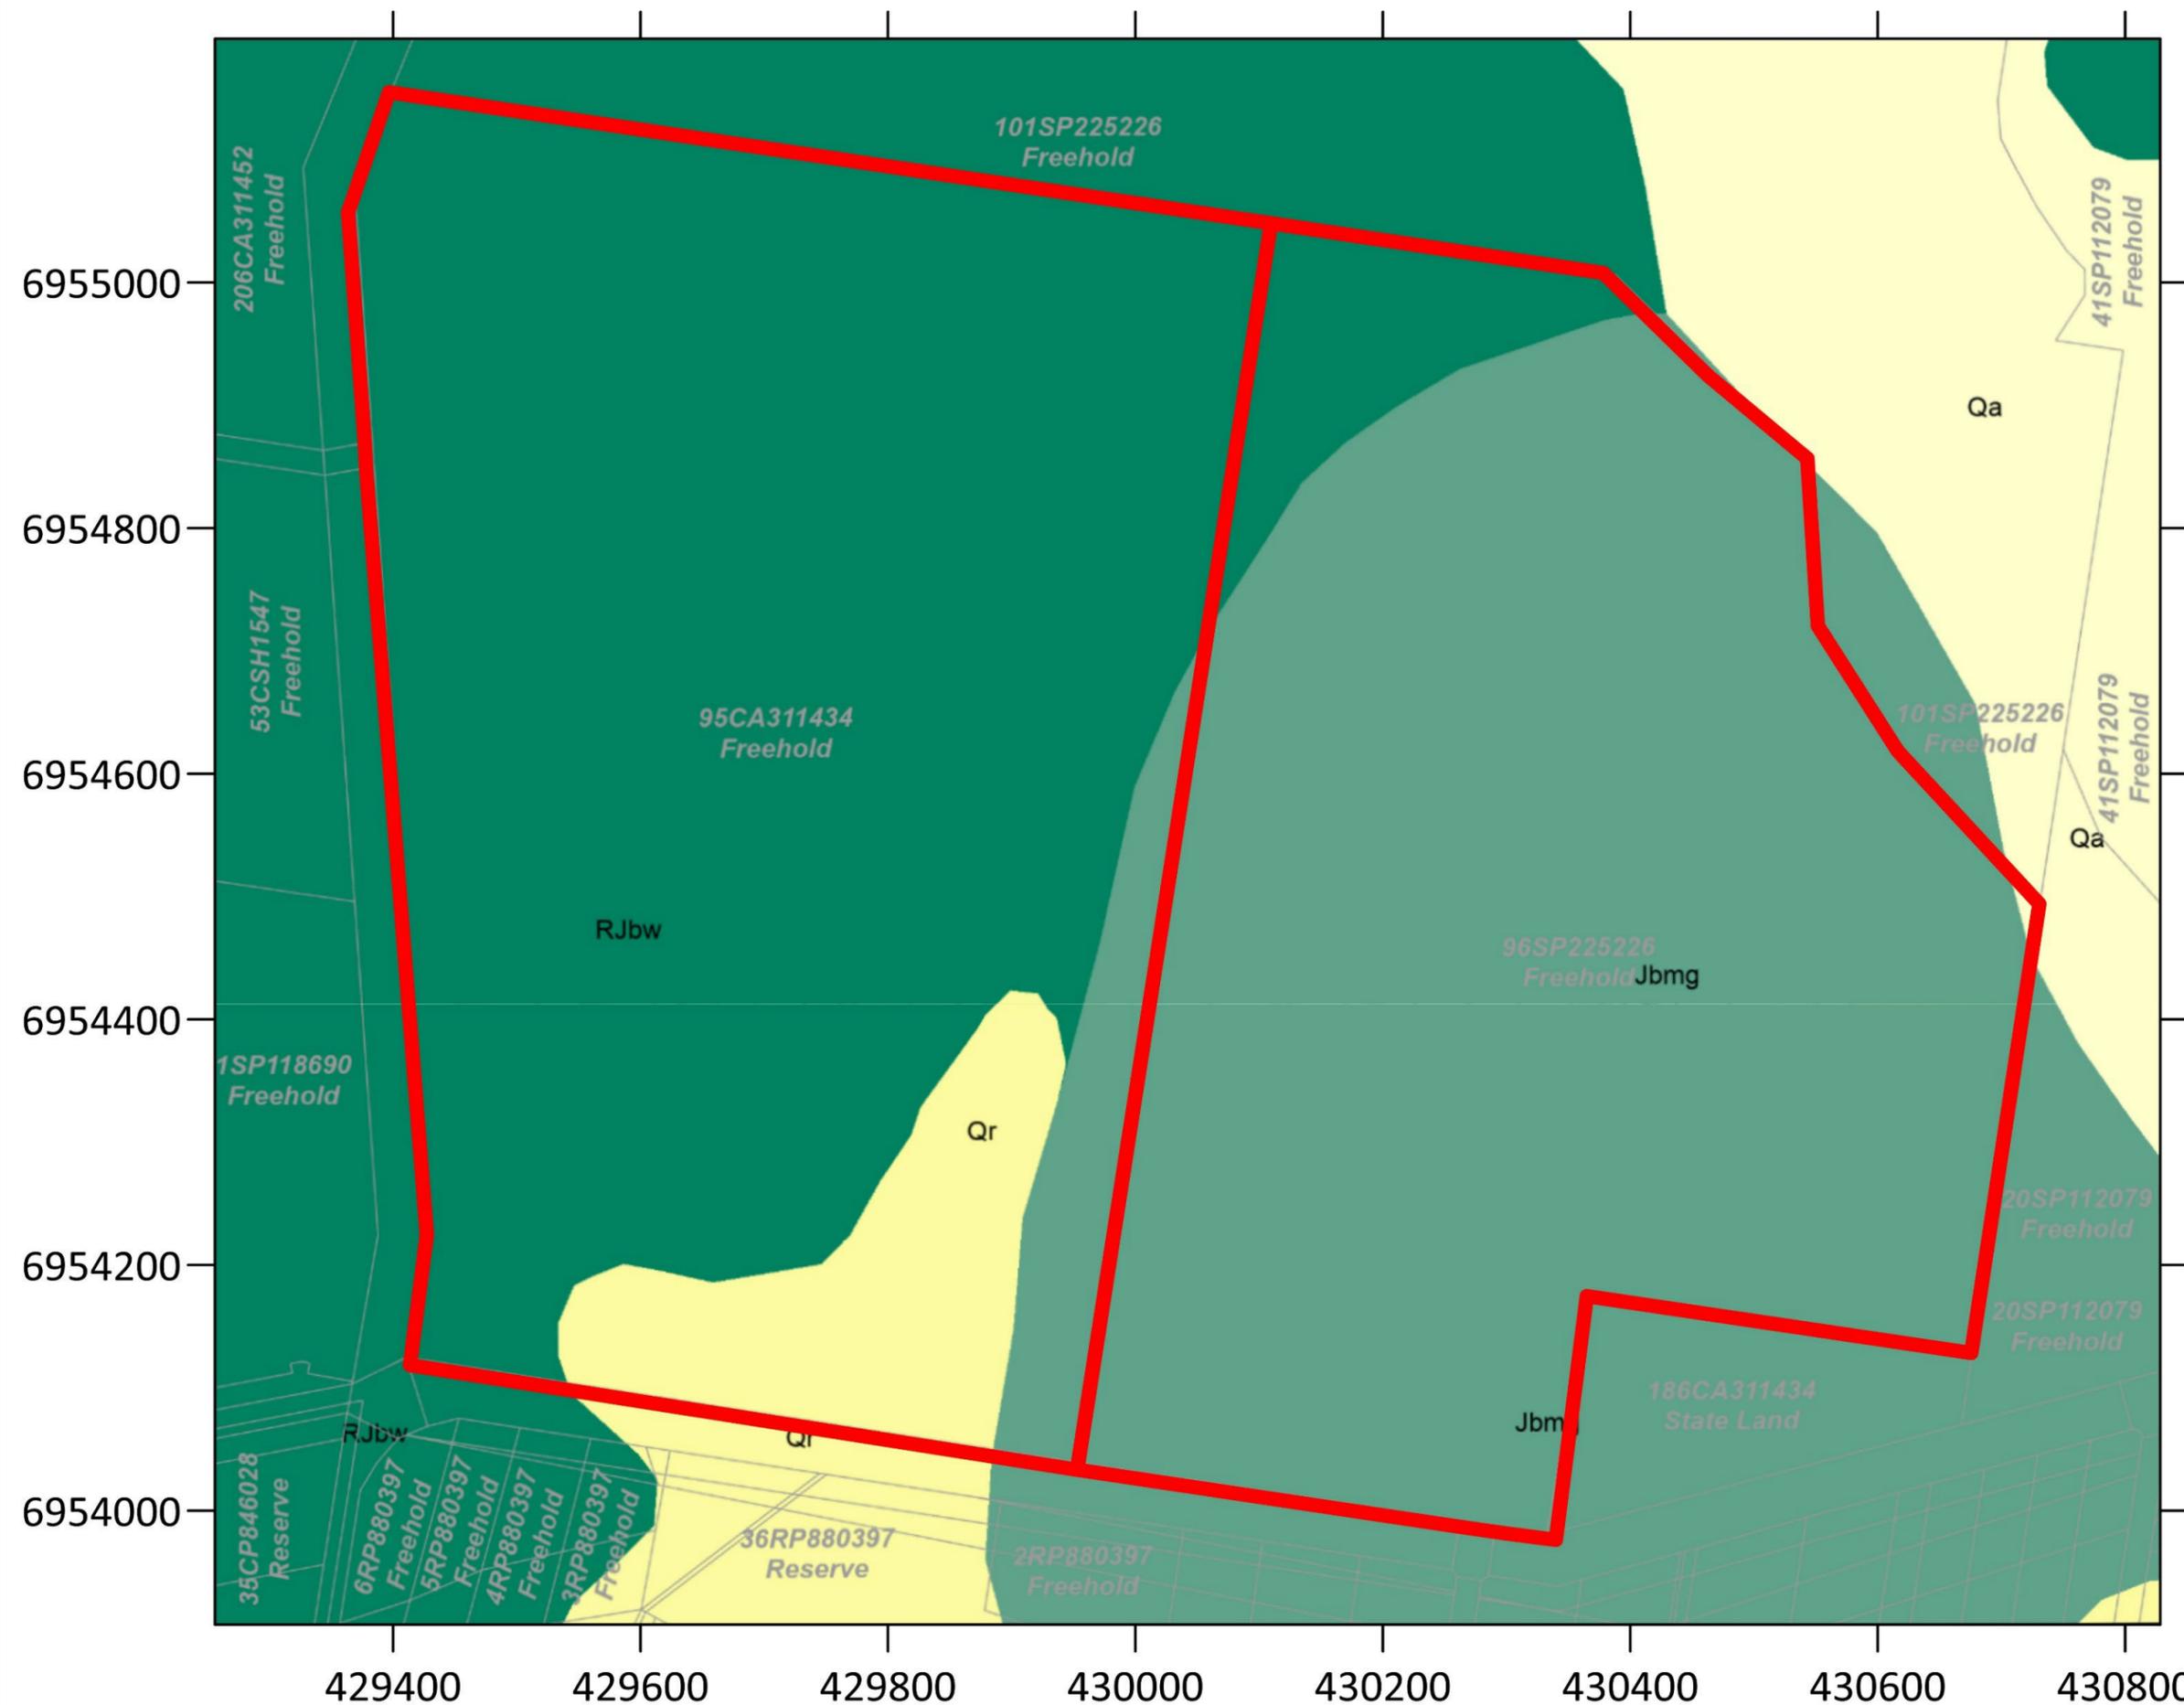
Title: Regional Geology

**Qa-QLD (Qa)**
- Clay, silt, sand and gravel; flood-plain alluvium

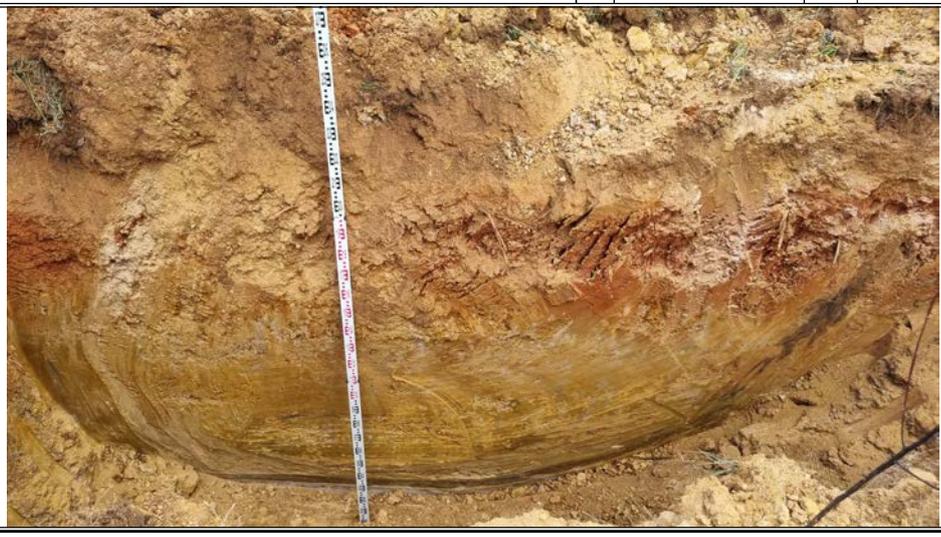
RL (m)	Depth (m)	Drilling Method	Graphic Log	Layer Depths	Material Description	Water	Strength (Consistency, Relative Density, Rock Strength)	Sampling & Testing		Dynamic Penetrometer Test (blows per 100 mm)
								Type	Results & Comments

117.5	0			0	TOPSOIL/GRASS - SM silty SAND, brown, fine to coarse grained, low plasticity fines, moist			0		5
	0.1			0.1	SP SAND with gravel, grey, loose, fine to coarse sand, fine to medium gravel, moist		Loose	0.1		1

0.4			0.4	CH silty sandy CLAY, dark red mottled white, stiff, medium plasticity fines, fine to medium sand, moist		Stiff	0.5		1
117.0	0.6			0.6	- very stiff		Very Stiff	0.6	PP=200 kPa	2

1.0			1.0				0.7	PP=200 kPa	3
	1.2			1.2	SM silty SAND with gravel, brown-orange mottled white, dense, fine to coarse sand, low plasticity fines, fine gravel, moist; extremely weathered sandstone		Dense		PP=250 kPa	7

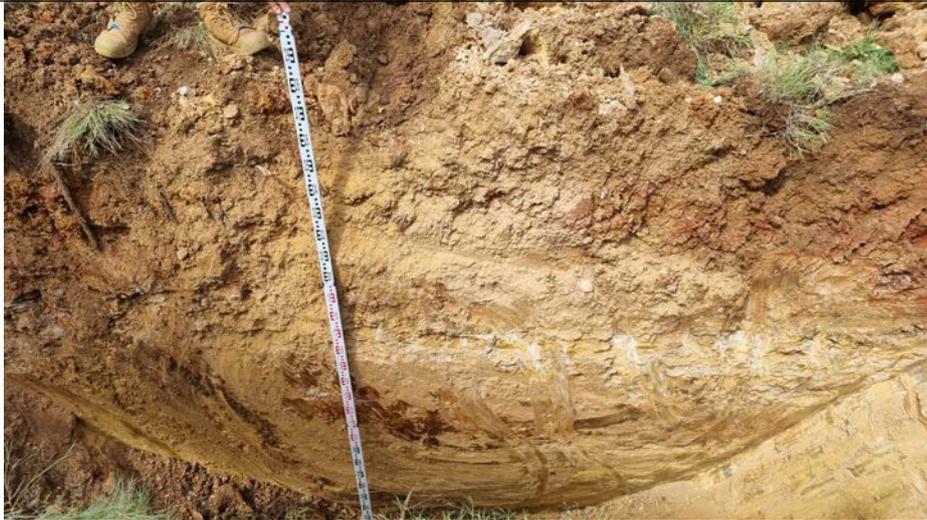
RL (m)	Depth (m)	Drilling Method	Graphic Log	Layer Depths	Material Description	Water	Strength (Consistency, Relative Density, Rock Strength)	Sampling & Testing		Dynamic Penetrometer Test (blows per 100 mm)
								Type	Results & Comments

121.5	0			0	TOPSOIL/GRASS - SM silty SAND, brown, loose, fine to coarse grained, low plasticity fines, moist					5 10 15 20
	0.1			0.1	SM silty SAND, brown, loose, fine to coarse grained, low plasticity fines, moist		Loose			1

0.2			0.2	SP SAND trace silt, grey, loose, fine to coarse sand, low plasticity fines, moist			B		2
	0.4			0.4	CH silty sandy CLAY, brown-orange mottled red-brown, stiff, high plasticity fines, fine sand, moist		Stiff	D	PP=150 kPa	3

121.0	0.6			0.6	SM silty SAND with gravel, orange mottled brown mottled white, very dense, fine to coarse sand, low plasticity fines, fine gravel, moist; extremely weathered sandstone		Very Dense		PP=200 kPa	6

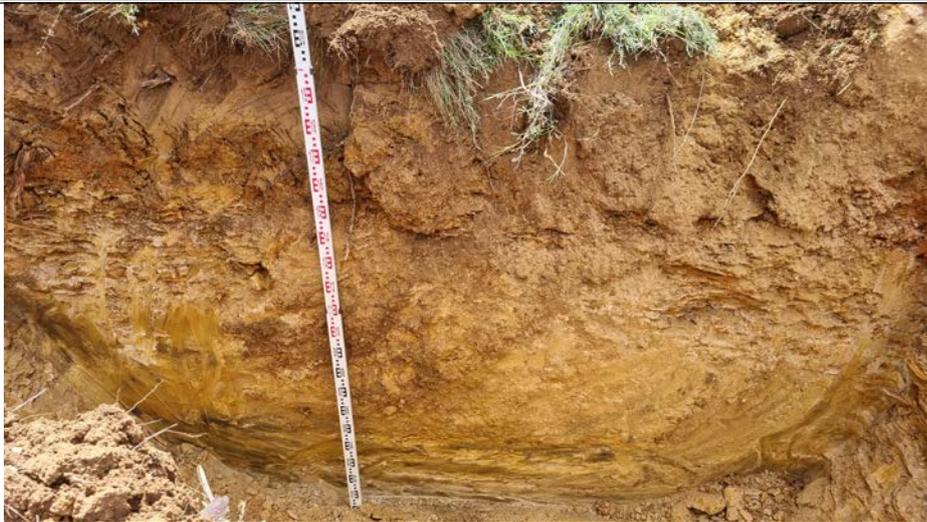
RL (m)	Depth (m)	Drilling Method	Graphic Log	Layer Depths	Material Description	Water	Strength (Consistency, Relative Density, Rock Strength)	Sampling & Testing		Dynamic Penetrometer Test (blows per 100 mm)
								Type	Results & Comments	
				0	TOPSOIL/GRASS - SM silty SAND, dark brown, very loose, fine to coarse sand, low plasticity fines, moist					5 10 15 20

0.1	GP silty sandy GRAVEL, pale brown, very loose, fine to medium gravel, fine to coarse sand, low plasticity fines, moist		Very Loose			1
120.0				0.3	CH CLAY with sand and silt, brown-orange mottled grey and red-brown, firm, high plasticity fines, fine to coarse sand, moist		Firm	D	PP=250 kPa	1

0.5			0.4	- stiff		Stiff			3
				0.7	- very stiff		Very Stiff	D	PP=600 kPa	8
119.5				0.9	SANDSTONE, brown-orange with white lenses, very low strength, fine grained, highly weathered, dry; interbedded layers of possible dry fissured clay					3

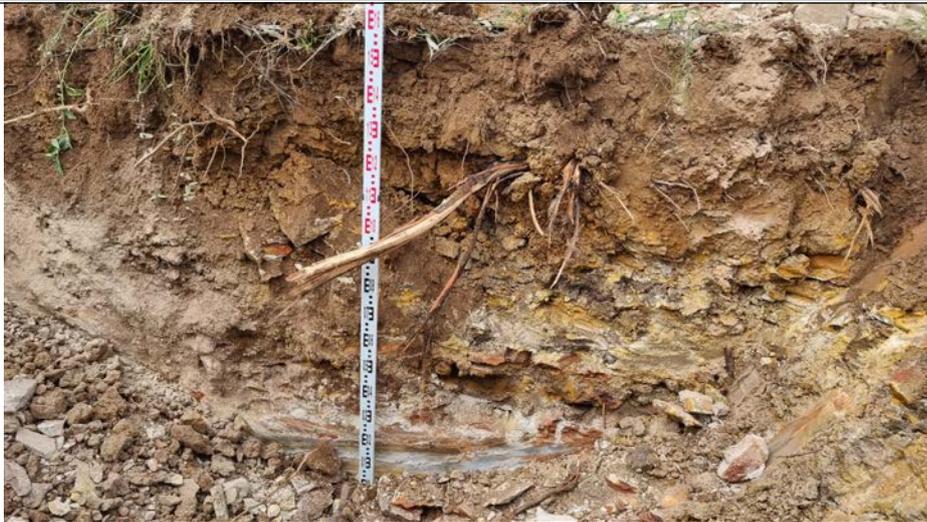
TEST PIT 6

RL (m)	Depth (m)	Drilling Method	Graphic Log	Layer Depths	Material Description	Water	Strength (Consistency, Relative Density, Rock Strength)	Sampling & Testing		Dynamic Penetrometer Test (blows per 100 mm)
								Type	Results & Comments	
				0	TOPSOIL/GRASS - SM silty SAND, dark brown, medium dense, fine to coarse sand, low plasticity fines, moist; cobbles throughout					5 10 15 20

0.1	GP GRAVEL with sand and silt, pale brown, medium dense, fine to medium gravel, fine to coarse sand, moist; cobbles throughout		Medium Dense			3

112.0				0.3	CH silty sandy CLAY, grey mottled orange and red-brown, stiff, high plasticity fines, fine to medium sand, moist		Stiff		PP=150 kPa	12
	0.5			0.5	SM silty SAND with gravel, red-brown mottled white, dense, fine to coarse sand, low plasticity fines, fine gravel, moist; extremely weathered sandstone		Dense			3

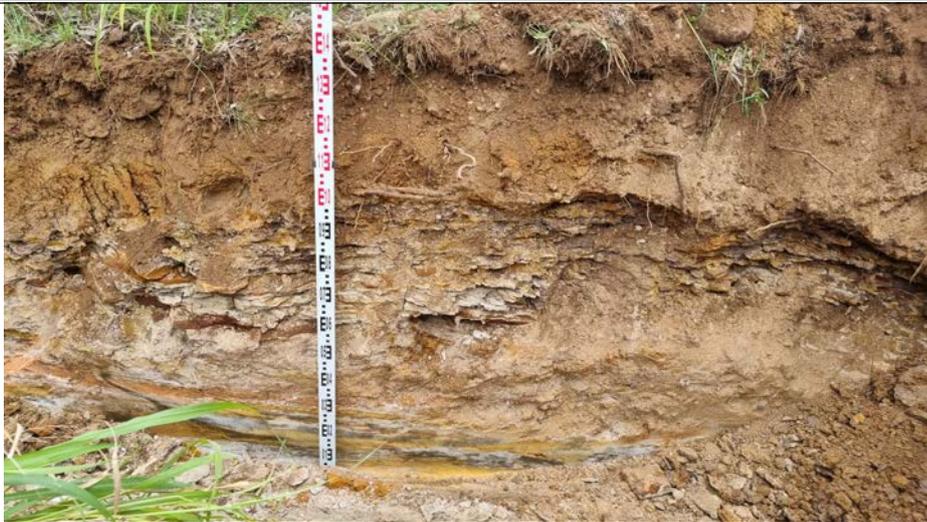
TEST PIT 7

114.0	0			0	TOPSOIL/GRASS - SM silty SAND with gravel, brown, loose, fine to coarse sand, low plasticity fines, fine to medium gravel, moist		Loose			1

0.1			0.1	SM silty SAND with gravel, brown, medium dense, fine to coarse sand, low plasticity fines, fine to medium gravel, moist		Medium Dense			7
	0.2			0.2	SP SAND with silt, pale brown, medium dense, fine to coarse sand, low plasticity fines, moist		Medium Dense			8

0.4			0.4	CH silty CLAY with sand, grey mottled red-brown and brown-orange, stiff, high plasticity fines, fine sand, moist		Stiff			9
113.5	0.6			0.6	SANDSTONE, pale brown with brown-orange lenses, low strength, fine to medium grained, highly weathered, dry		Low Strength			10

0.7			0.7	- red-brown, medium strength, excavation difficulty increased		Medium Strength			3
	0.95				Test Pit terminated at 0.95 m. 20T CAT Excavator refusal on medium strength sandstone.					20 / 80 mm

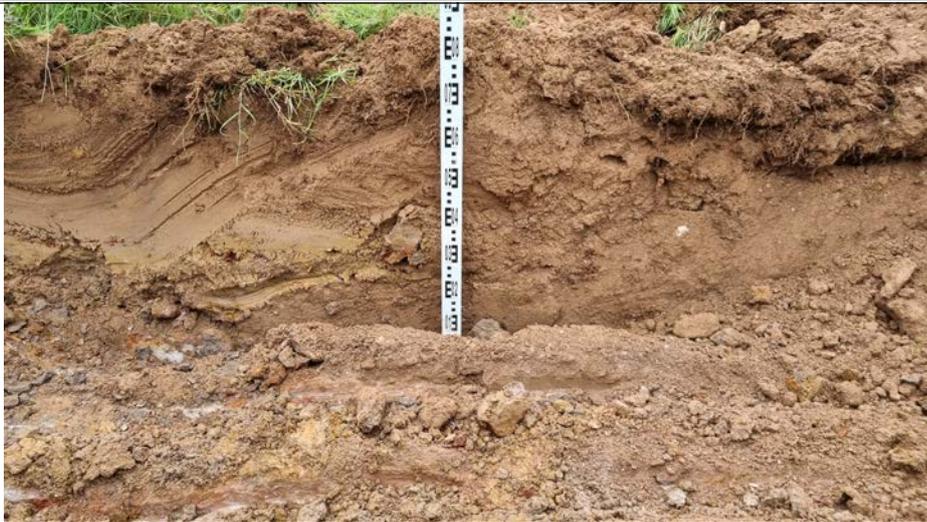
RL (m)	Depth (m)	Drilling Method	Graphic Log	Layer Depths	Material Description	Water	Strength (Consistency, Relative Density, Rock Strength)	Sampling & Testing		
								Type	Results & Comments	Dynamic Penetrometer Test (blows per 100 mm)
				0	TOPSOIL/GRASS - SM silty SAND trace clay, dark brown, loose, fine to coarse sand, low plasticity fines, moist					5 10 15 20

0.1	SM silty SAND trace clay, dark brown, loose, fine to coarse sand, low plasticity fines, moist					
				0.2	CH silty sandy CLAY, brown mottled orange and grey, stiff, high plasticity fines, fine to medium sand, moist

114.0	0.5			0.4	- very stiff					
				0.5	- hard					
				0.6	- orange mottled pale brown					
113.5	1.0			1	- grey					
113.0	1.5			1.5	SANDSTONE, orange-brown, very low strength, fine to coarse grained, highly weathered, dry; friable

112.5	2.0			1.8	- low strength					
112.0	2.5				Test Pit terminated at 2.1 m. 20T CAT Excavator refusal on low strength sandstone.					
111.5	3.0

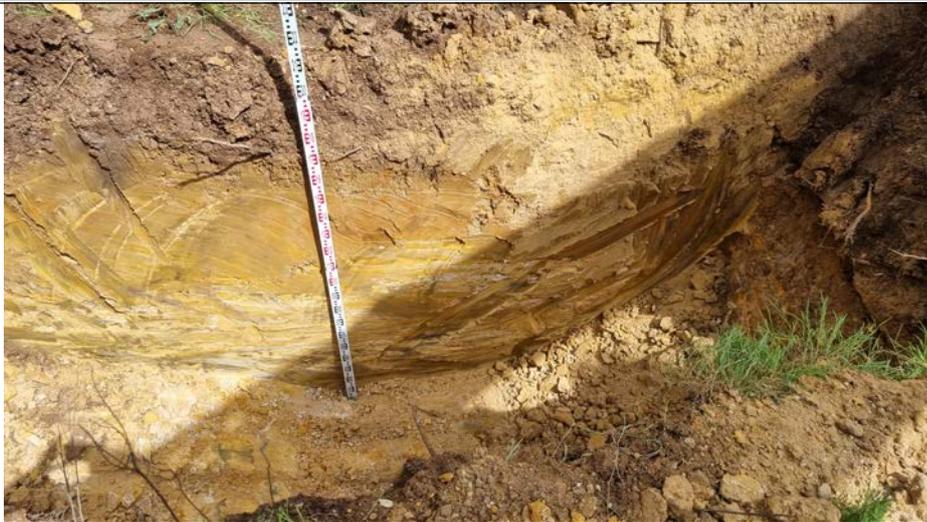
RL (m)	Depth (m)	Drilling Method	Graphic Log	Layer Depths	Material Description	Water	Strength (Consistency, Relative Density, Rock Strength)	Sampling & Testing		Dynamic Penetrometer Test (blows per 100 mm)
								Type	Results & Comments	
				0	TOPSOIL/GRASS - SM silty SAND, dark brown, loose, fine to coarse grained, low plasticity fines, moist					5 10 15 20

0.1	SM silty SAND, dark brown, loose, fine to coarse grained, low plasticity fines, moist		Loose			1 2
				0.3	CH silty CLAY with sand, dark brown mottled red, stiff, high plasticity fines, fine to coarse sand, moist		Stiff	0.3	PP=100 kPa	2 3 4

124.0	1.5									
				1.8	- pale brown-orange, low strength					
123.5	2.0			1.9	- orange mottled white		Low Strength			
					Test Pit terminated at 2 m. 20T CAT Excavator refusal on low strength sandstone.

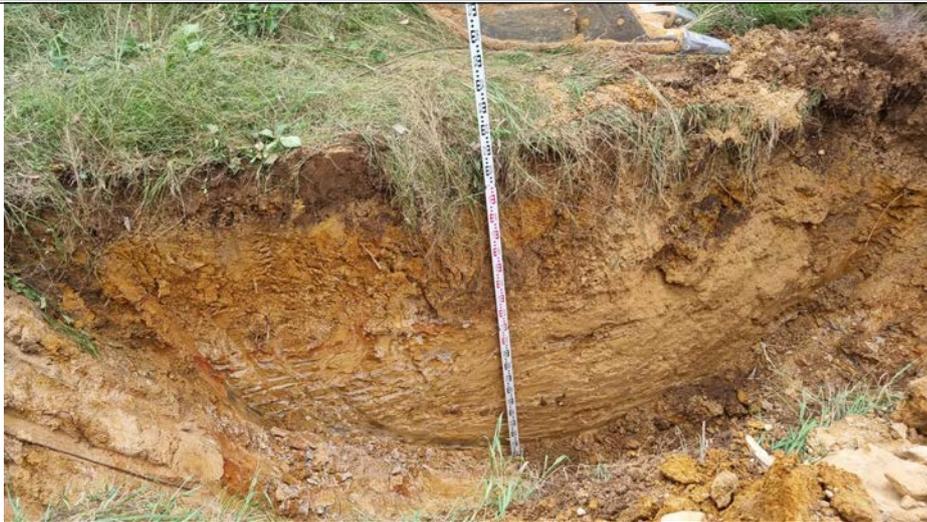
RL (m)	Depth (m)	Drilling Method	Graphic Log	Layer Depths	Material Description	Water	Strength (Consistency, Relative Density, Rock Strength)	Sampling & Testing		Dynamic Penetrometer Test (blows per 100 mm)
								Type	Results & Comments	
115.5	0.0			0	TOPSOIL/GRASS - SM silty SAND, dark brown, loose, fine to coarse sand, low plasticity fines, moist					1
	0.2			0.2	SP SAND with silt and gravel, brown, loose, fine to coarse sand, low plasticity fines, fine to medium gravel, moist		Loose	D		2
	0.5			0.5	- red-brown					2
115.0	0.7			0.7	SANDSTONE, red-brown with orange-brown lenses, very low strength, fine to medium grained, dry		Very Low Strength			5
	1.0			1	- low strength		Low Strength			13
114.5	1.3				Test Pit terminated at 1.3 m. 20T CAT Excavator refusal on medium strength sandstone.					20 / 20 mm
114.0	1.5									
113.5	2.0									
113.0	2.5									
	3.0
